# Walkability Audit

18<sup>th</sup> November 2016

**St Bodens NS**

**Culdaff**

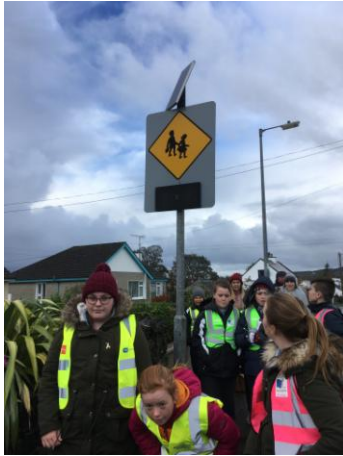
School signs keep us safe

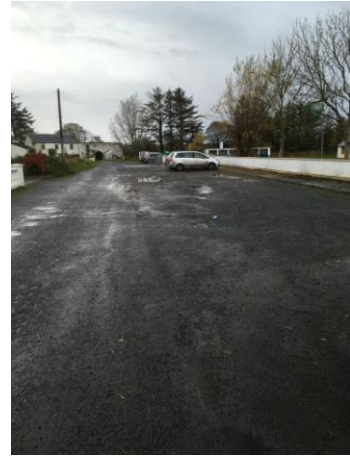
Parking markings should be re-painted outside the school

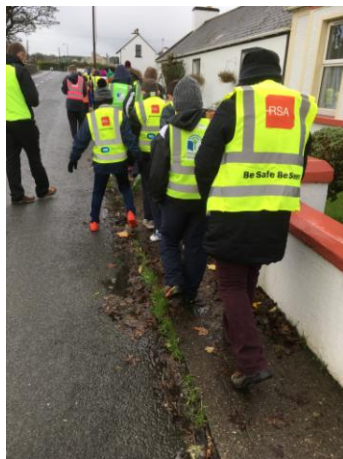
Caution required on narrow pavements

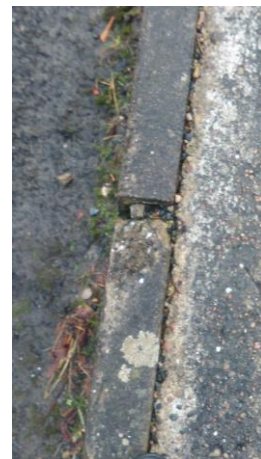
Some pavements cracked

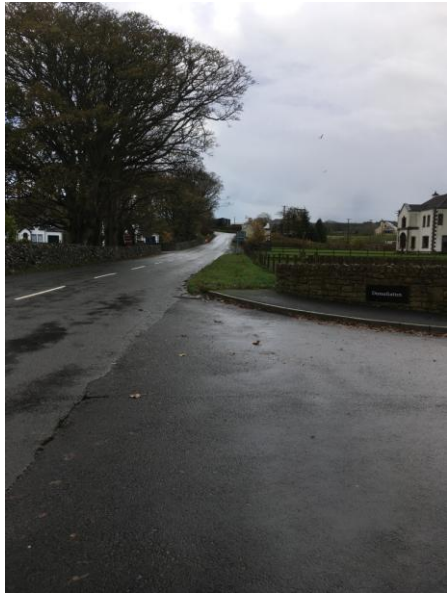
Pavements should be extended past the Dun Alainn estate

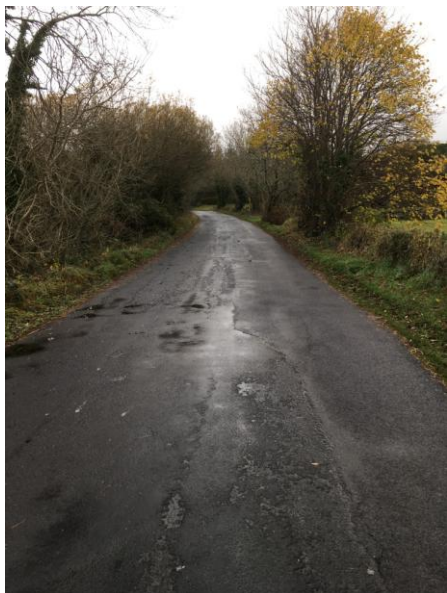
Pavements should be extended past the Clara Bay estate
